Chief Complaint

64 year old male presents with the chief complaint "I want to fix my smile"

Treatment Plan

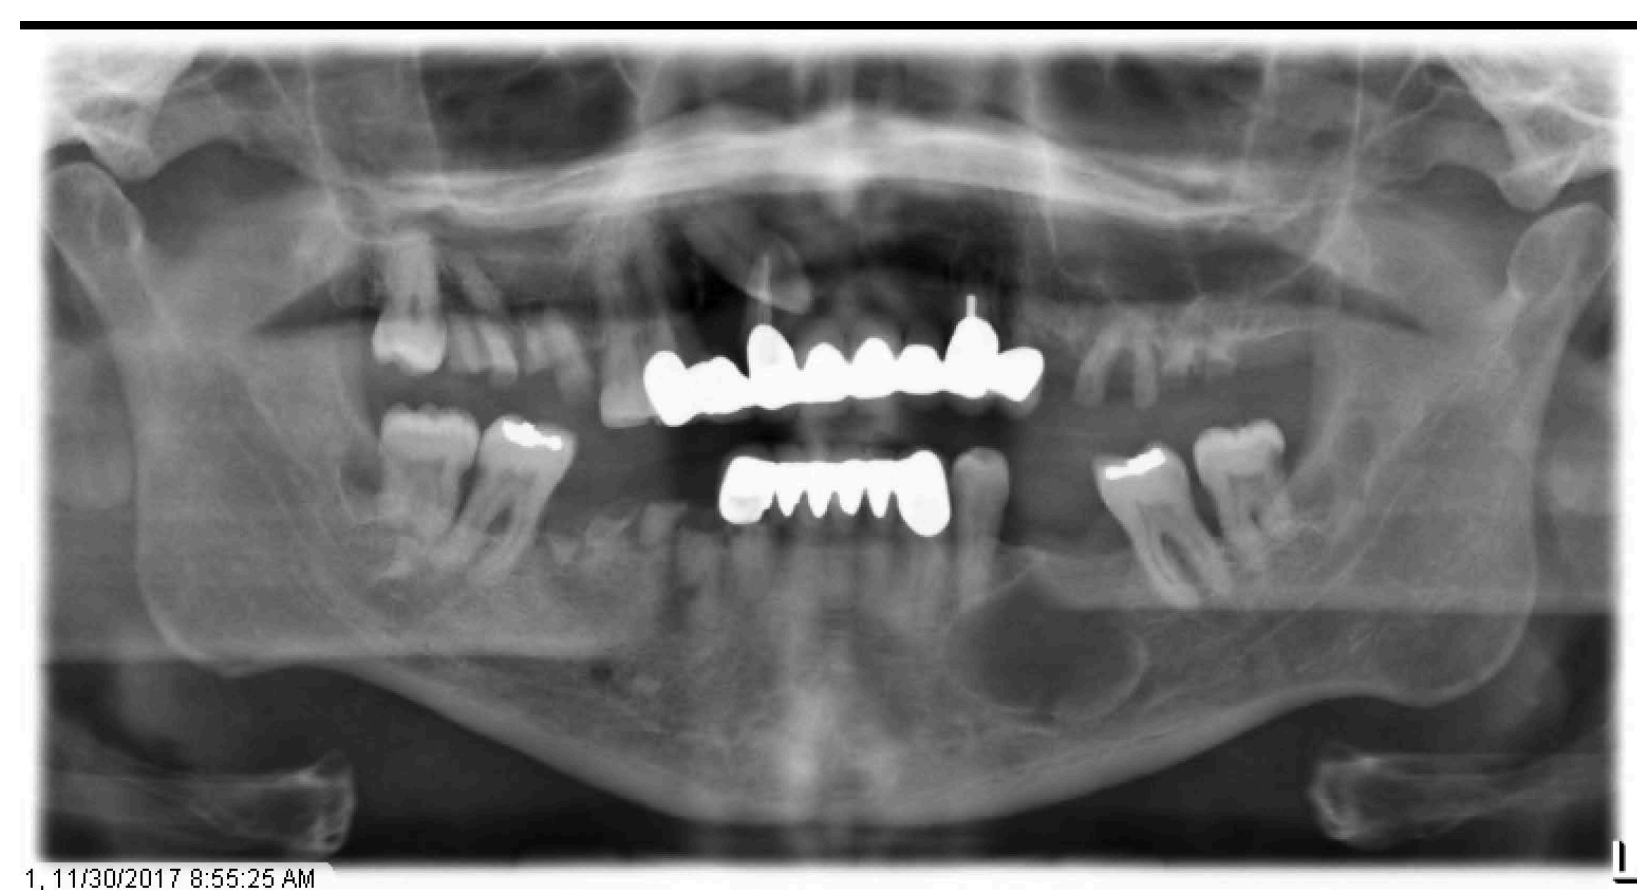
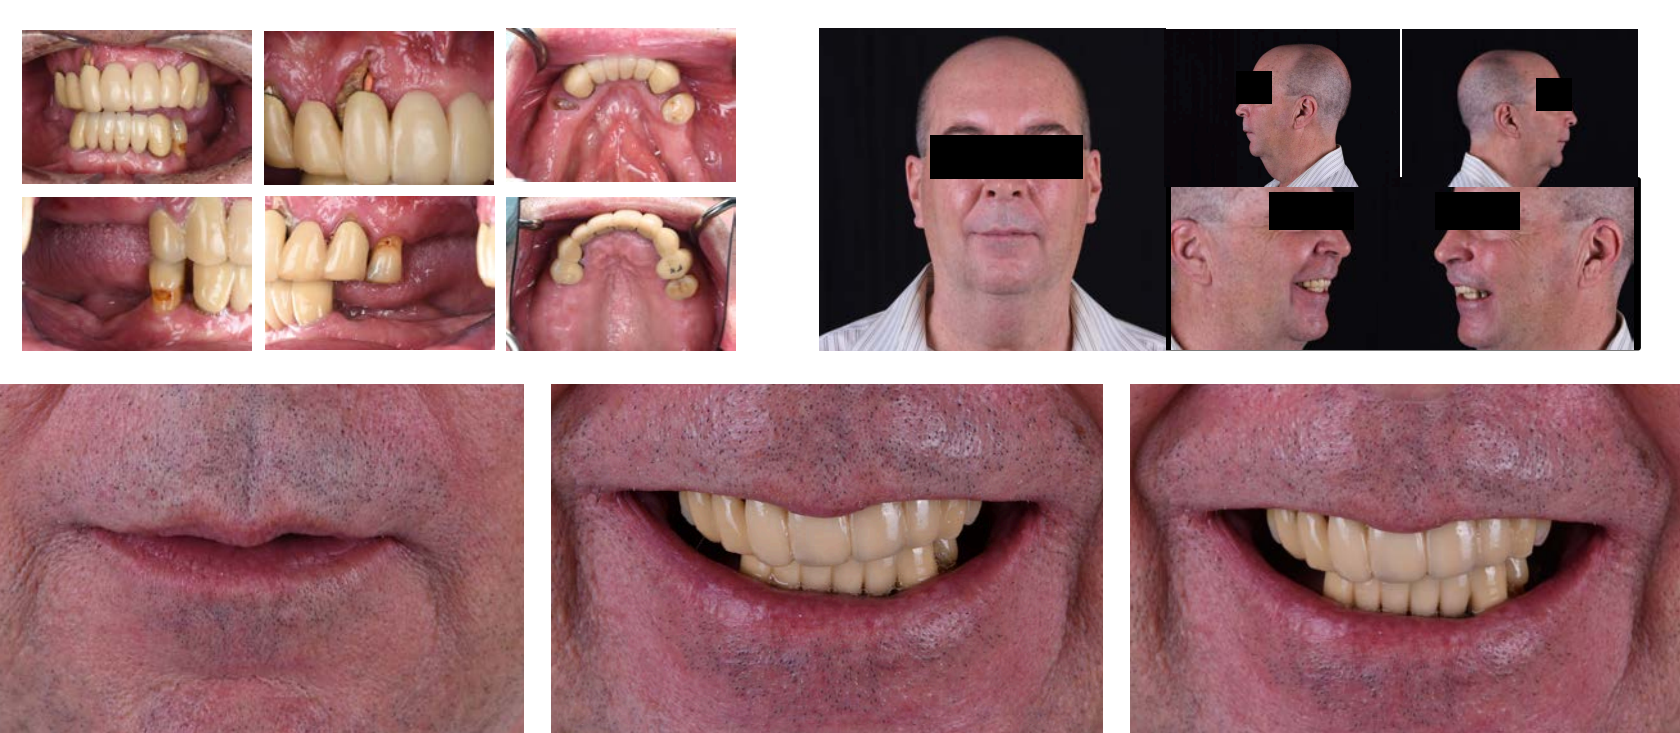
Panoramic Radiograph, Intra-oral Images, Facial/Smile Analysis

- Restorative work done in 1980's including upper and lower fixed dental prostheses
- Last outside dental visit 1990's
- Presents to Upenn School of Dental Medicine 2020
- Remaining dentition: #1-7,11,12,14,15, 17,18,21,22,27-32
- #6 impacted
 - Metal mesh placed in defect along with collatape
 - With removal of impacted #6, #11 + 12 fail (fractured)
 - Dehiscence of #10 with gutta-percha exposure
 - Fixed dental prosthesis no longer viable
- Lower left mandibular cyst
 - Removed via excisional biopsy + peripheral osteotomy
 - Biopsy result → Odontogenic keratocyst

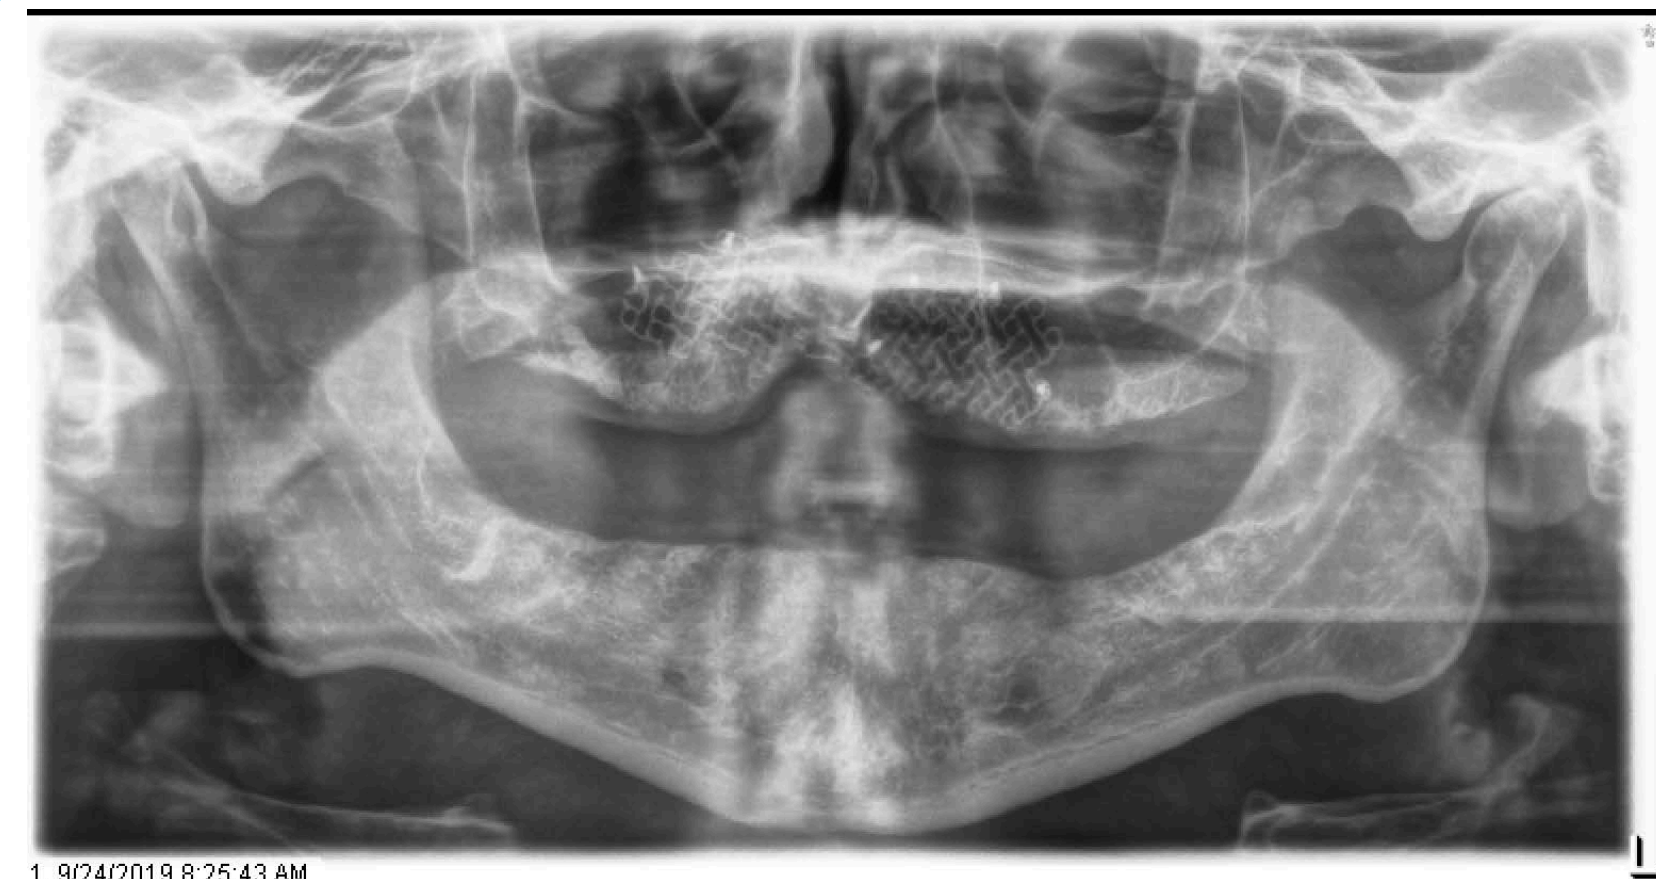
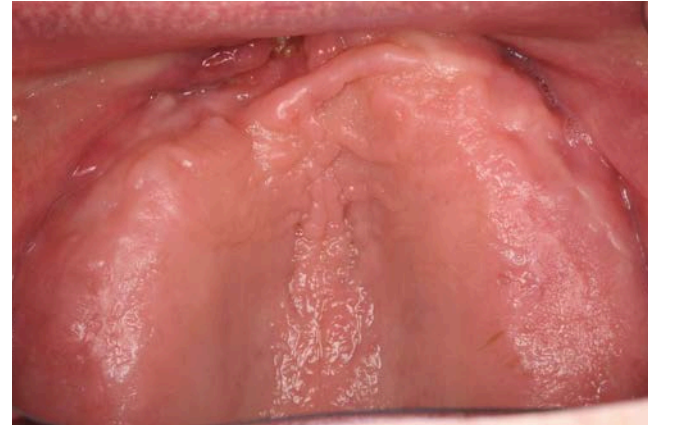
Siebert Class III Defect

- Required for all three treatment options
 - Guided tissue regeneration at sites #4,6,12
 - Bone grafting at sites #4,5,7,12
 - Interim denture failed due to maxillary alveolar defect and lack of retention

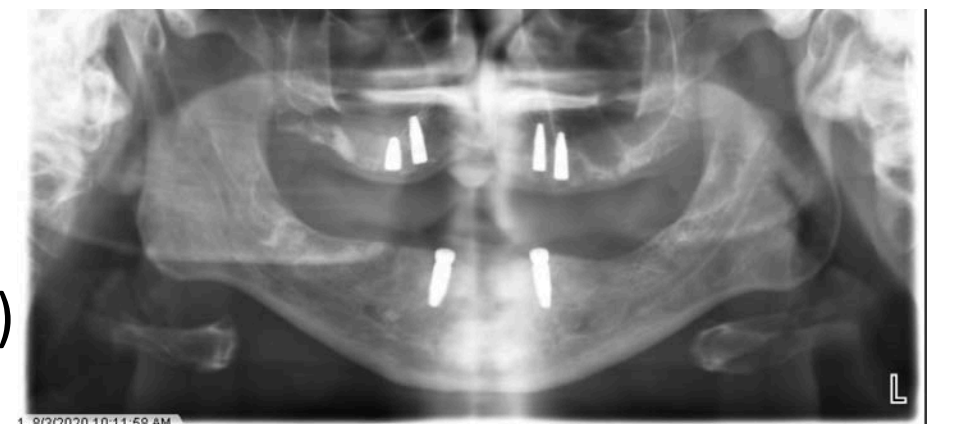
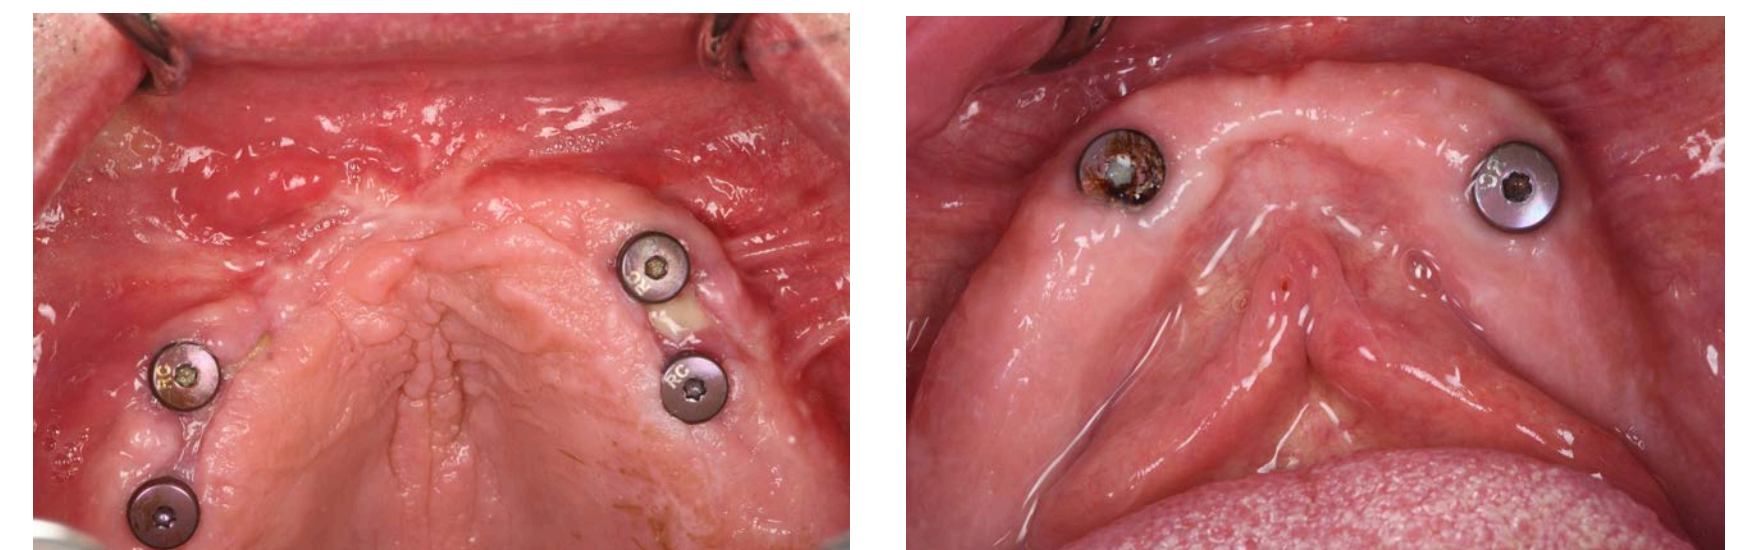
Implant Placement

- Remaining mandibular dentition extracted with bone grafting
- Straumann Implant placement
- Mandibular implants torqued to 40 Ncm
 - Healing abutments placed
- Left maxillary sinus lift
- Maxillary implants torqued to 34 Ncm (insufficient)
 - Cover screw placed
 - Second stage successfully performed → healing abutments placed

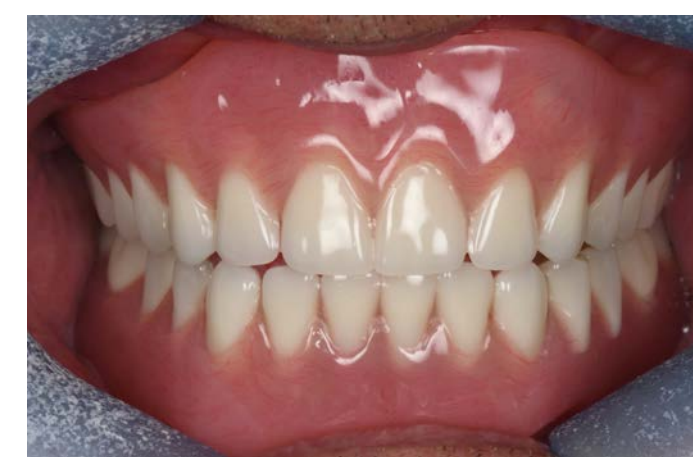
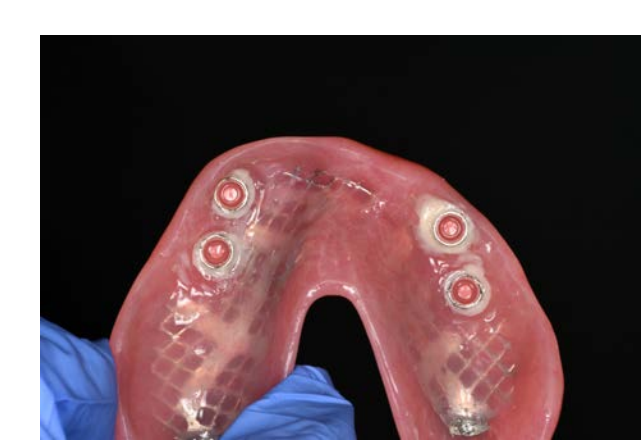
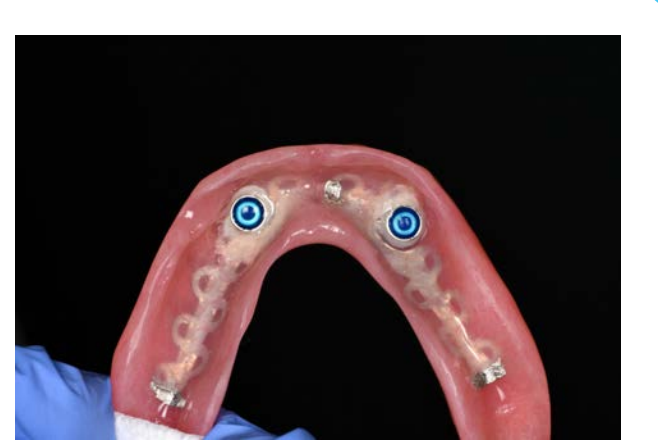
Prosthesis and Locator Attachments

- Mandibular Prosthesis: Extra Light Retention (Blue)
- Maxillary Prosthesis: Light Retention (Pink)

- Maxillary and Mandibular prostheses fabricated with metal frame works
- Locators picked up chair side
- Patient returned for follow up to assess retention of prostheses
 - Mandibular adequate retention → blue
 - Maxillary slightly inadequate retention → pink

- Ream out acrylic on intaglio surface to allow for locator
 - Check with Color Transfer Applicators to confirm location and clearance
- Place plastic ring on implant abutment to prevent subgingival extrusion of acrylic
- Attach locator with pickup gasket to abutment
- Mix thin acrylic and fill reamed out area, seat denture
 - Simultaneously pick up a locator on each side to ensure proper seating
- Remove excess acrylic around locators
