## INTRODUCTION

## CASE REPORT

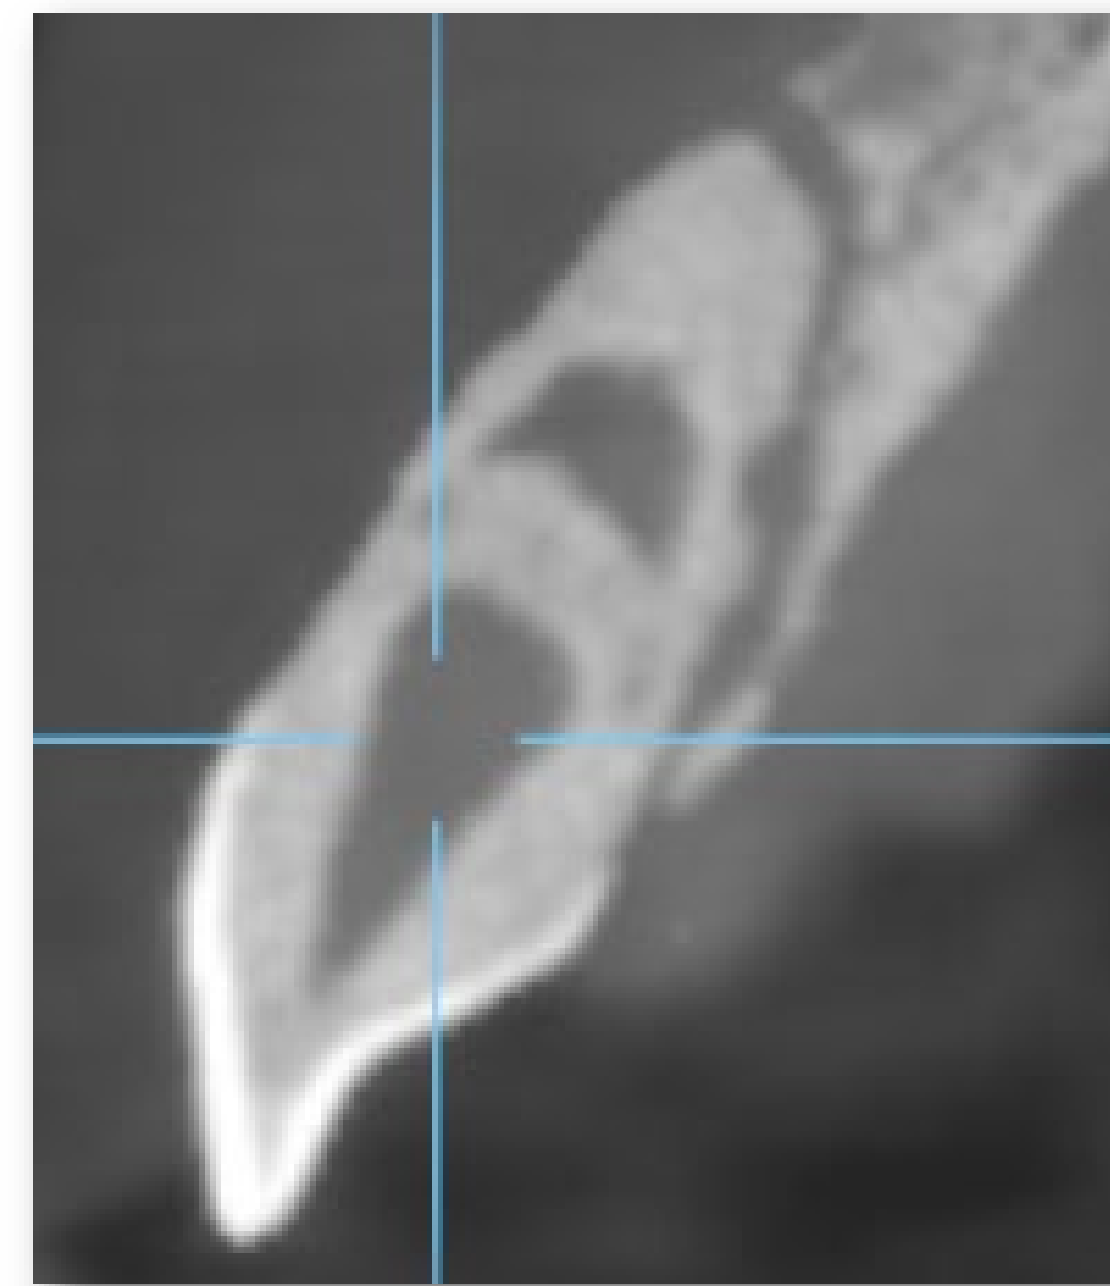
CBCT sagittal view

A 23-year-old female patient who attended the UADY Endodontic Clinic due to tooth pain in tooth No. 9. Radiographically, an atypical morphology was observed in the root canal, in addition to necrosis and sinus tract. CBCT showed the formation of a uniform dentin bridge at the level of the middle third of the root canal. The patient was anesthetized, absolute isolation was placed and the access was made, later the dentin bridge was crossed with an ED7 ultrasound tip. It was cleaned and  $\text{Ca}(\text{OH})_2$  was placed. At the second appointment, the  $\text{Ca}(\text{OH})_2$  was removed, irrigated with 5.25% NaOCl, and the two root chambers were filled with Bioceramic material (Biodentine™). Finally, the resin restoration was placed. **After a year, the patient is asymptomatic, sinus tract is absent and radiographically the periapical lesion is decreasing.** The prognosis remains reserved.

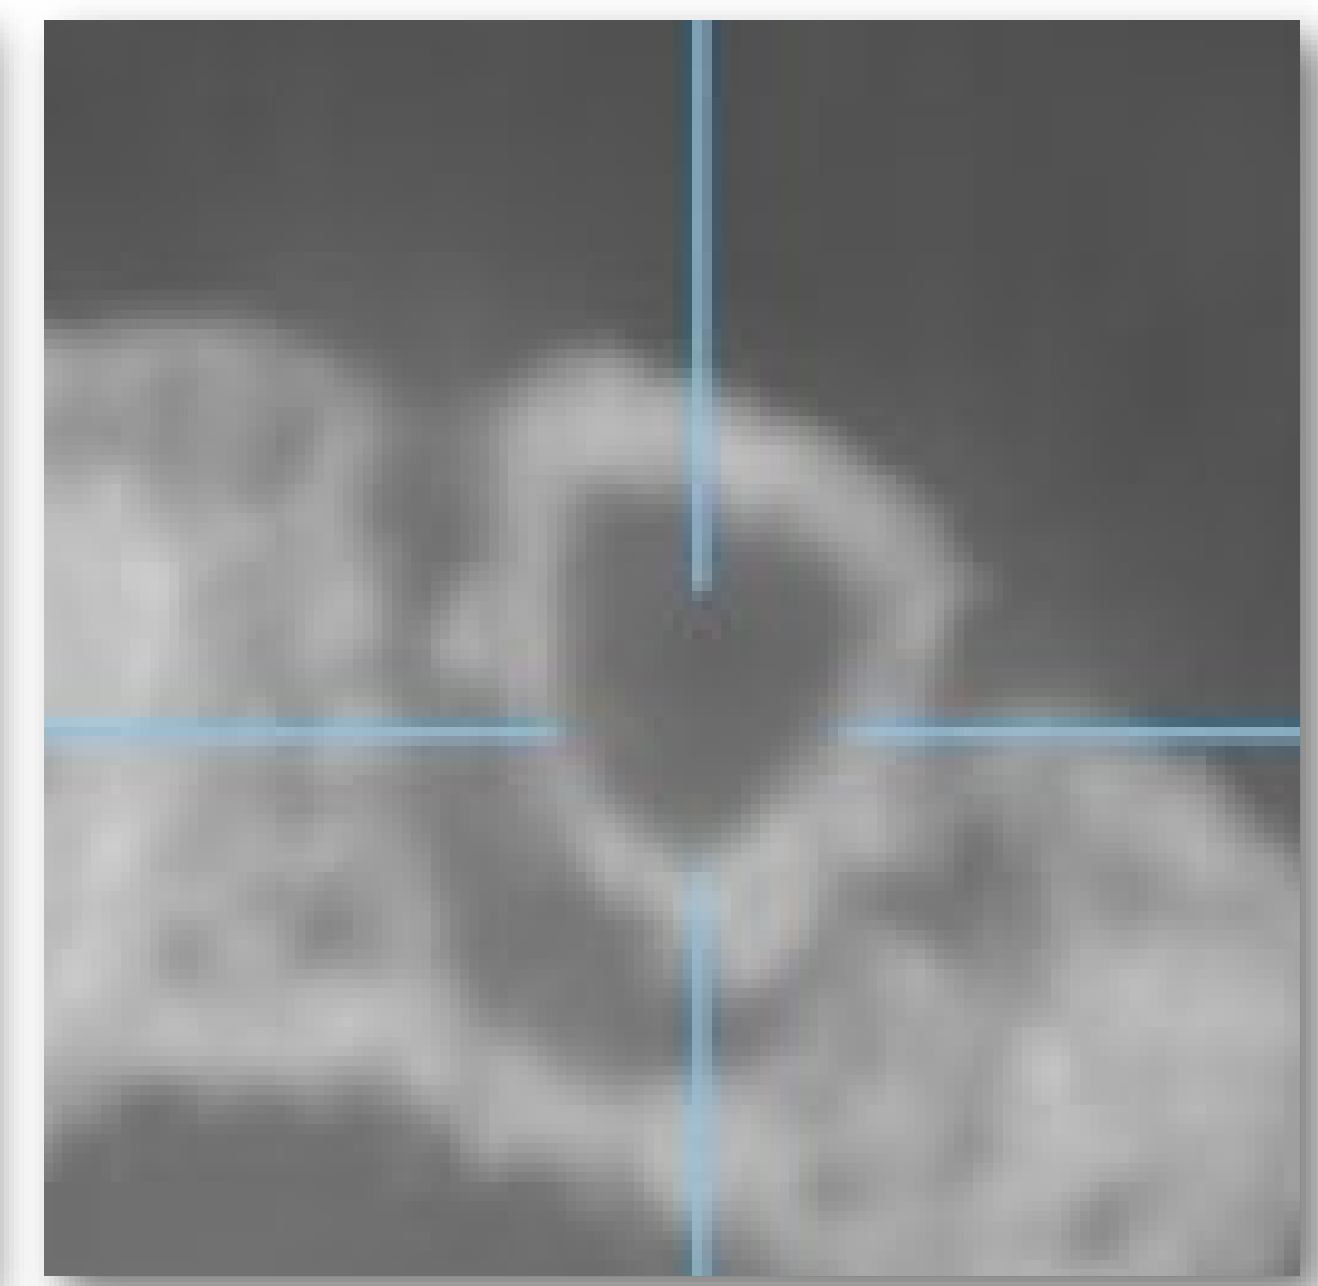
CBCT apical third

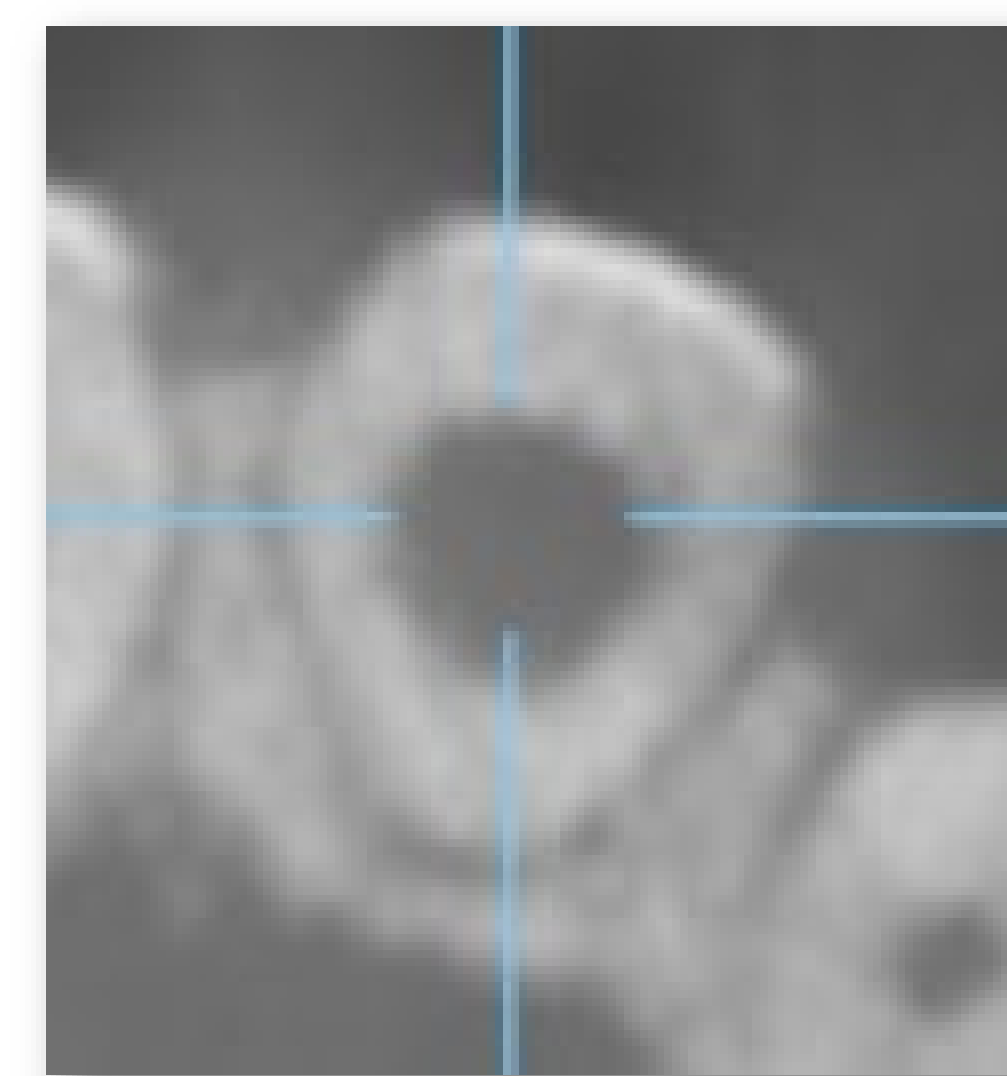
CBCT cervical third

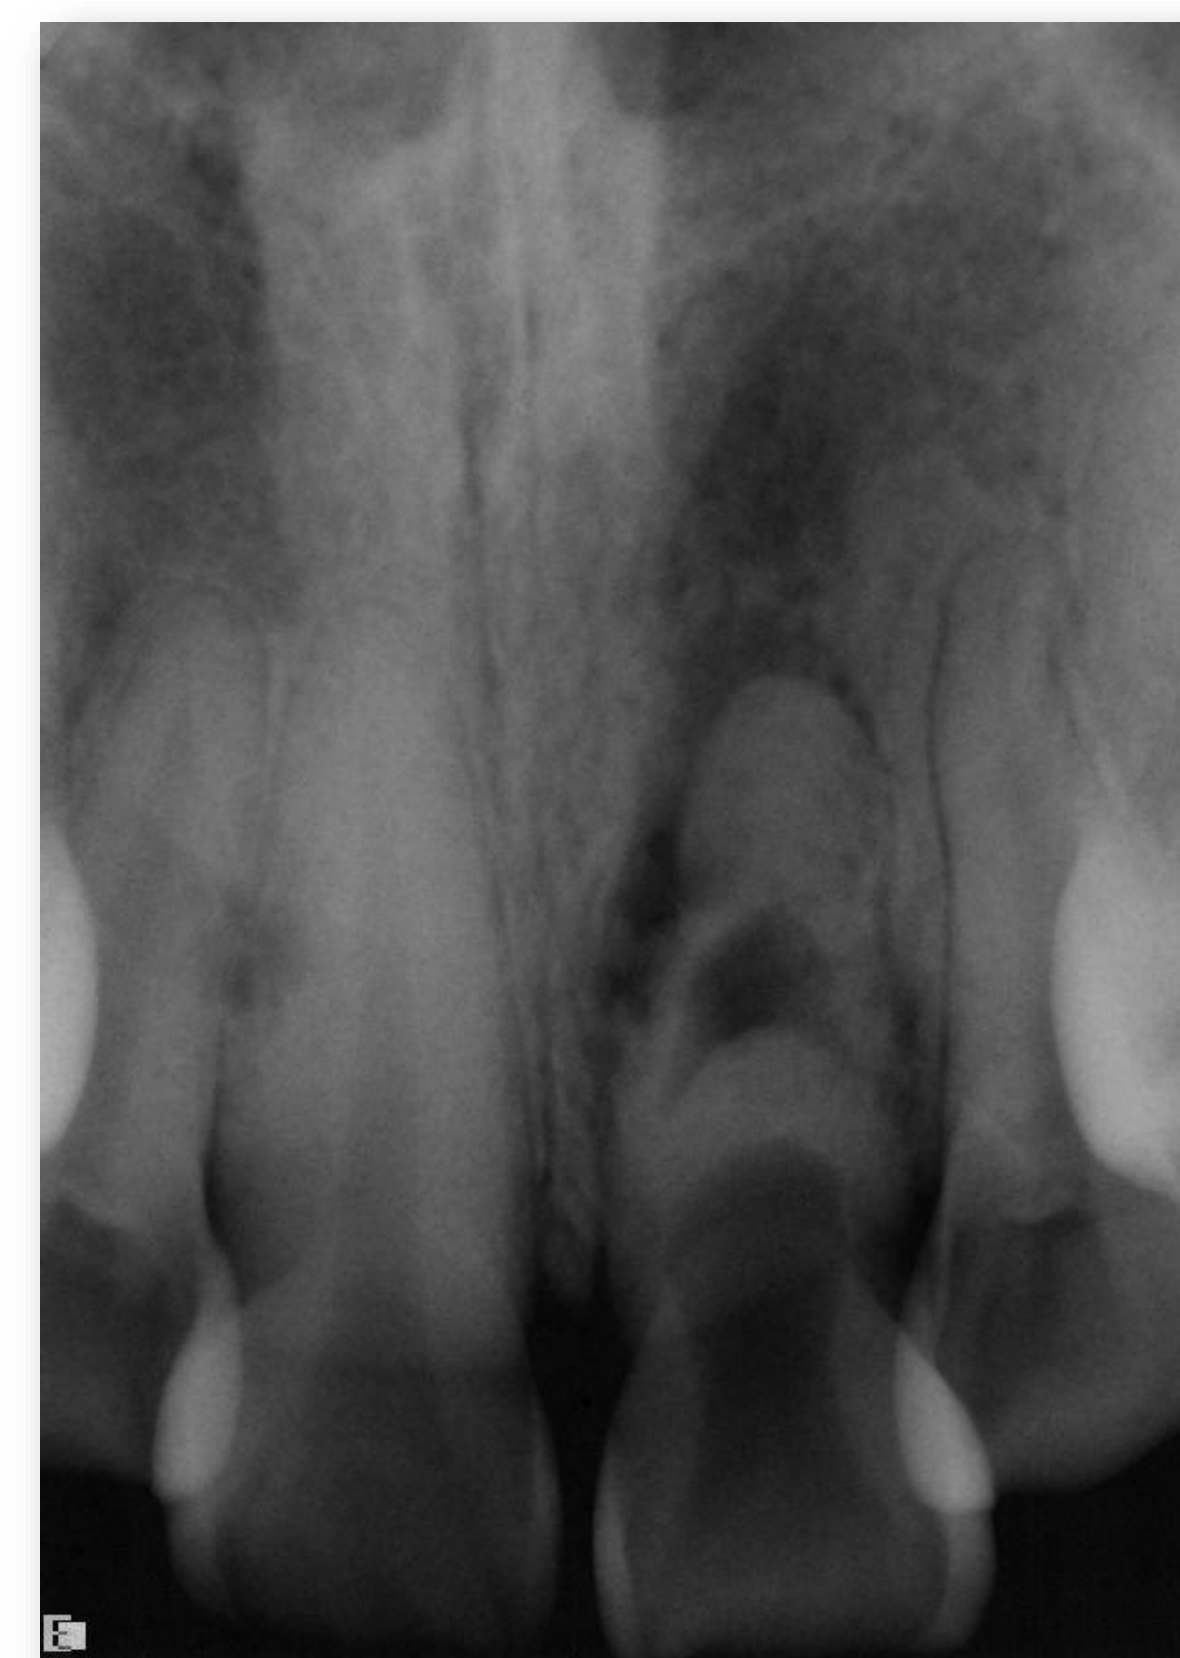
Initial Rx

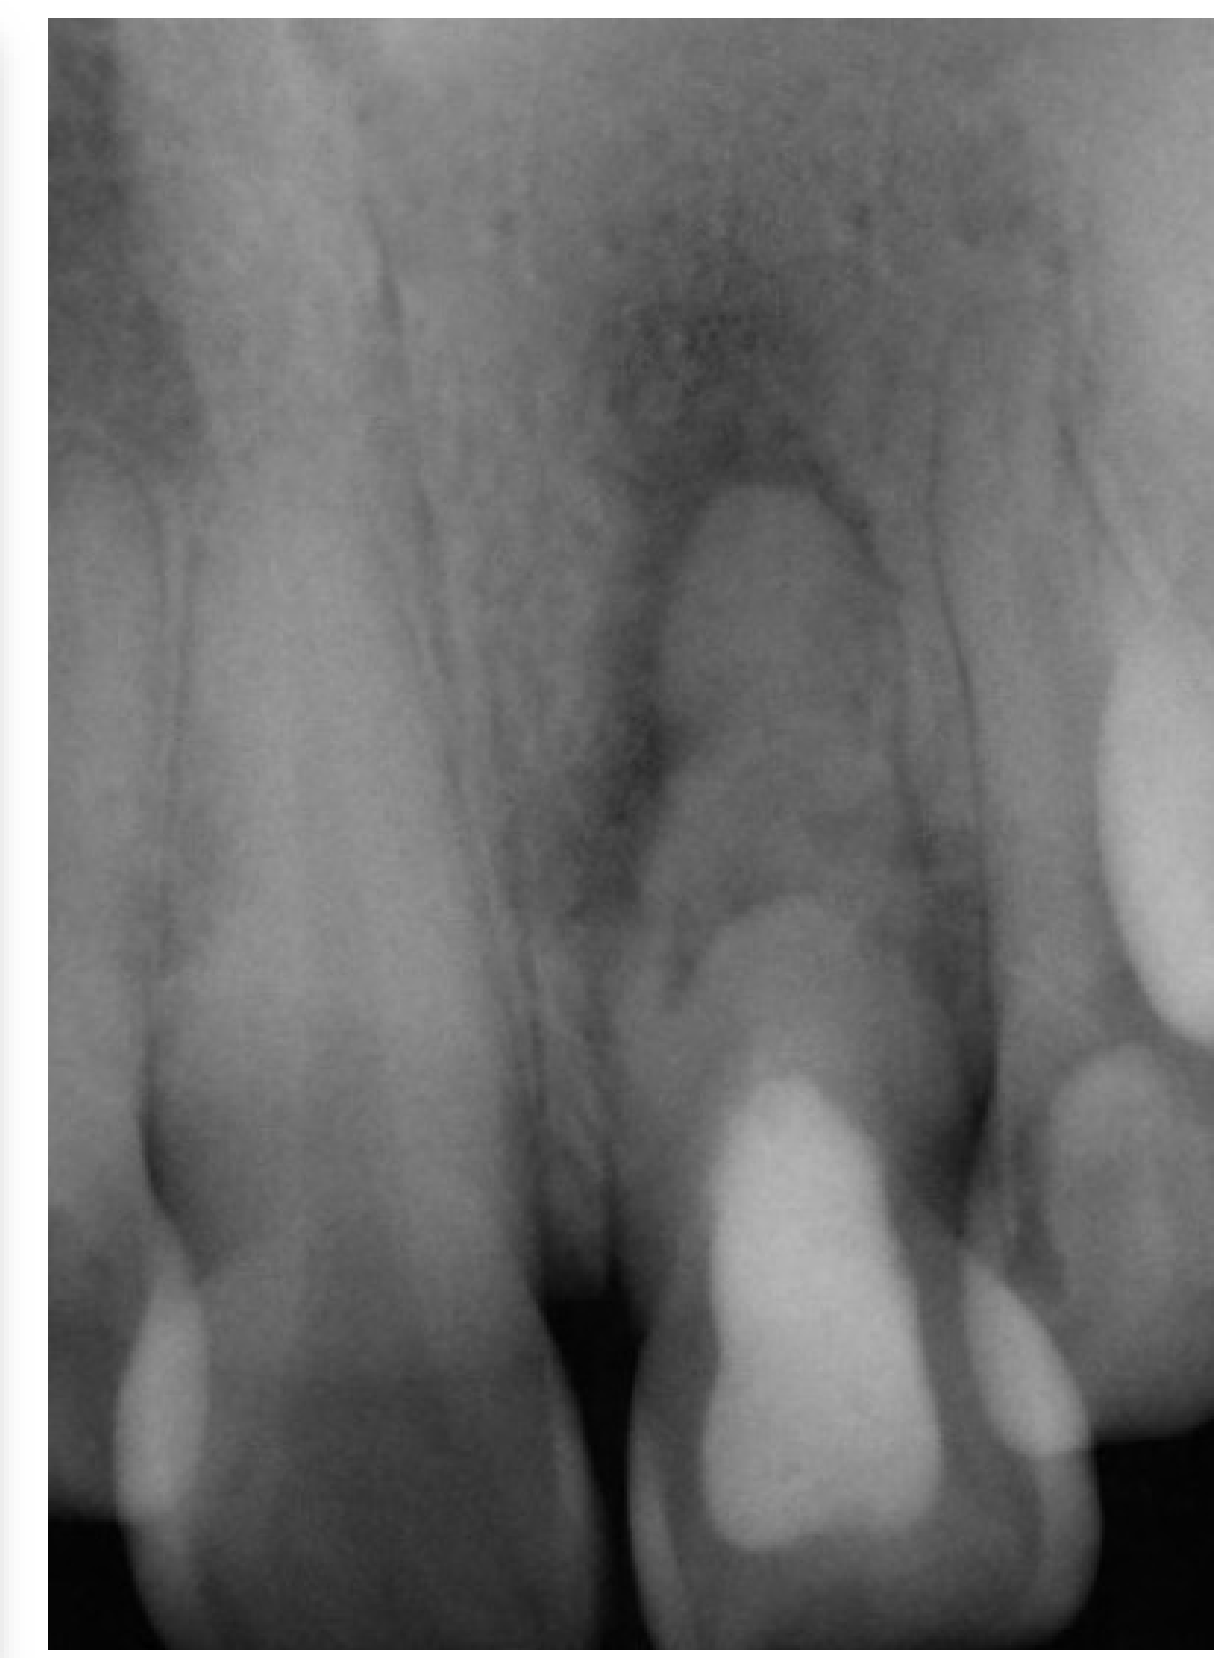
One-year follow up
