# Prosthodontic Management of Anterior Open Bite: Case Report

NYU College of Dentistry

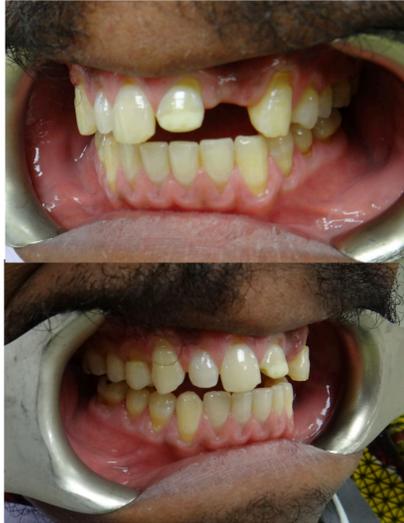
Figure 1. Anterior open bite

- 49-year old patient presented to the NYUCD Prosthodontic Department with the chief complaint of "I want a better smile."
- Upon initial examination, it became clear that the upper and lower anterior teeth did not meet (anterior open bite).
- Anterior open bite measured to be -1.5 mm (negative) overbite in canine occlusion with class I molar and canine relationship on both right and left side.
- #8 was chipped and #9 was fractured.
- Patient's left lateral incisor (tooth #10) was missing.
- Abfraction lesion on #5 was visible in the smile line.
- Convex facial profile and a competent lip.
- Class I recession on #20-29 which cannot be viewed from frontal view due to lip coverage.
- Large carious lesion on #17 into the pulp.

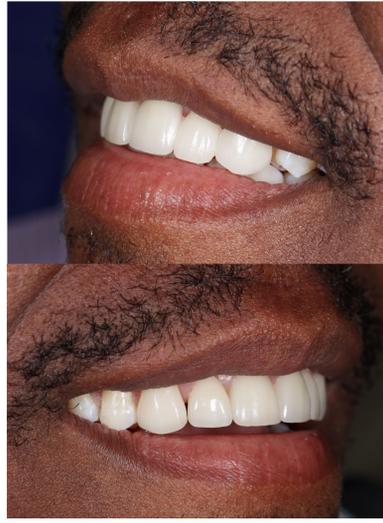
Figure 2. Final outcome lateral views

As a result, the open bite was closed sufficiently so that the patient was left with an esthetic result that he was confident with. The anterior overjet was within the acceptable 1-2 mm range.

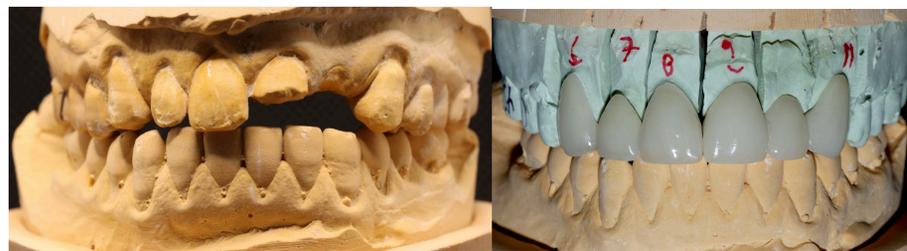
Figure 3. Open bite on diagnostic casts versus restorations

Prior to any tooth preparation, pre-operative photographs were taken in addition to preliminary impressions. Diagnostic casts were hand articulated due to posterior occlusion and mounted on a semi-adjustable articulator. A diagnostic wax-up was completed and used as a tool to communicate with the patient regarding the final outcome in addition to planning the necessary reduction required to place restorations. Diagnostic casts and wax-up were marked with important landmarks such as the midline and inter-canine distance. Gingival zeniths presented with optimal locations, and thus a gingivoplasty was deemed unnecessary. The smile line was approximated. The length of the teeth were determined using the incisal edges of the lower anterior teeth as a guide.

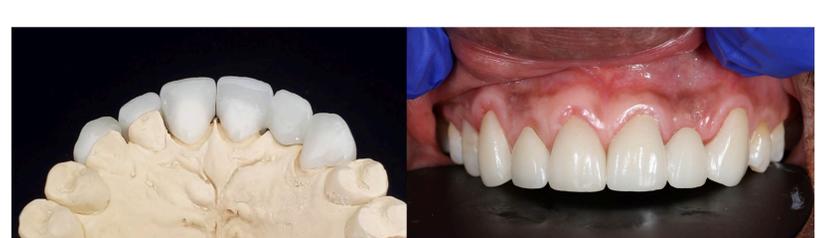
Figure 5. Ceramic occlusal and straight view

Instead, a three-unit zirconia bridge layered with E-max would be utilized to replace #10 with a modified ridge lap pontic using #9 and #11 as abutments. This specific material was chosen after careful consideration due to research that outlines zirconia frameworks with layered E-max being demonstrated to show exceptional color matches when masking a dark tooth (Aboushelib et al., 2010). Layered zirconia restorations also demonstrate high fracture resistance or low fracture rates (Abdulmajeed et al., 2017). To match the esthetics of the ceramic bridge from #9-11, Zirconia crown layered with E-max was planned for #8, and E-max veneers were planned for teeth #6 and #7. E-max restorations are made from lithium desilicated ceramic, and demonstrate durability, translucent color, and exceptional esthetics.
