Implant Placement in a Site with Periapical Pathology After Tooth Removal: A Case Report

Buddhapoom Wangsrimongkol, Tanatorn Asvaplungprohm, Raed O Kadi,, Huzefa Talib, Sttuart Froum, Sang Choon Cho, Department of Cariology and Comprehensive Care (Esthetic Dentistry), and Department of Periodontology and Implant Dentistry, NYU College of Dentistry

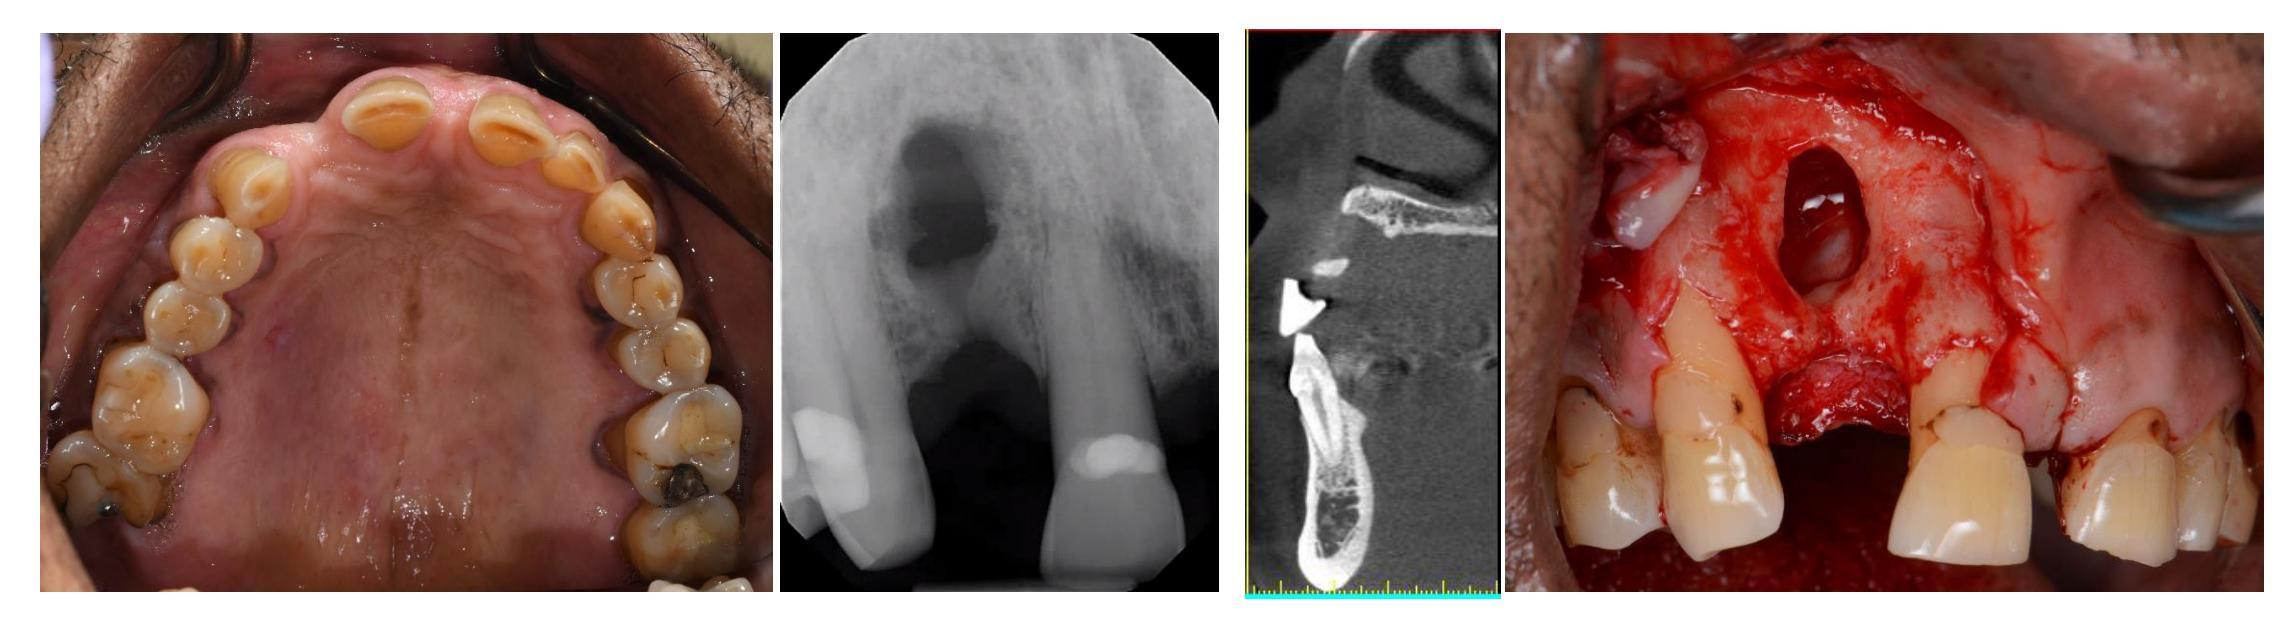
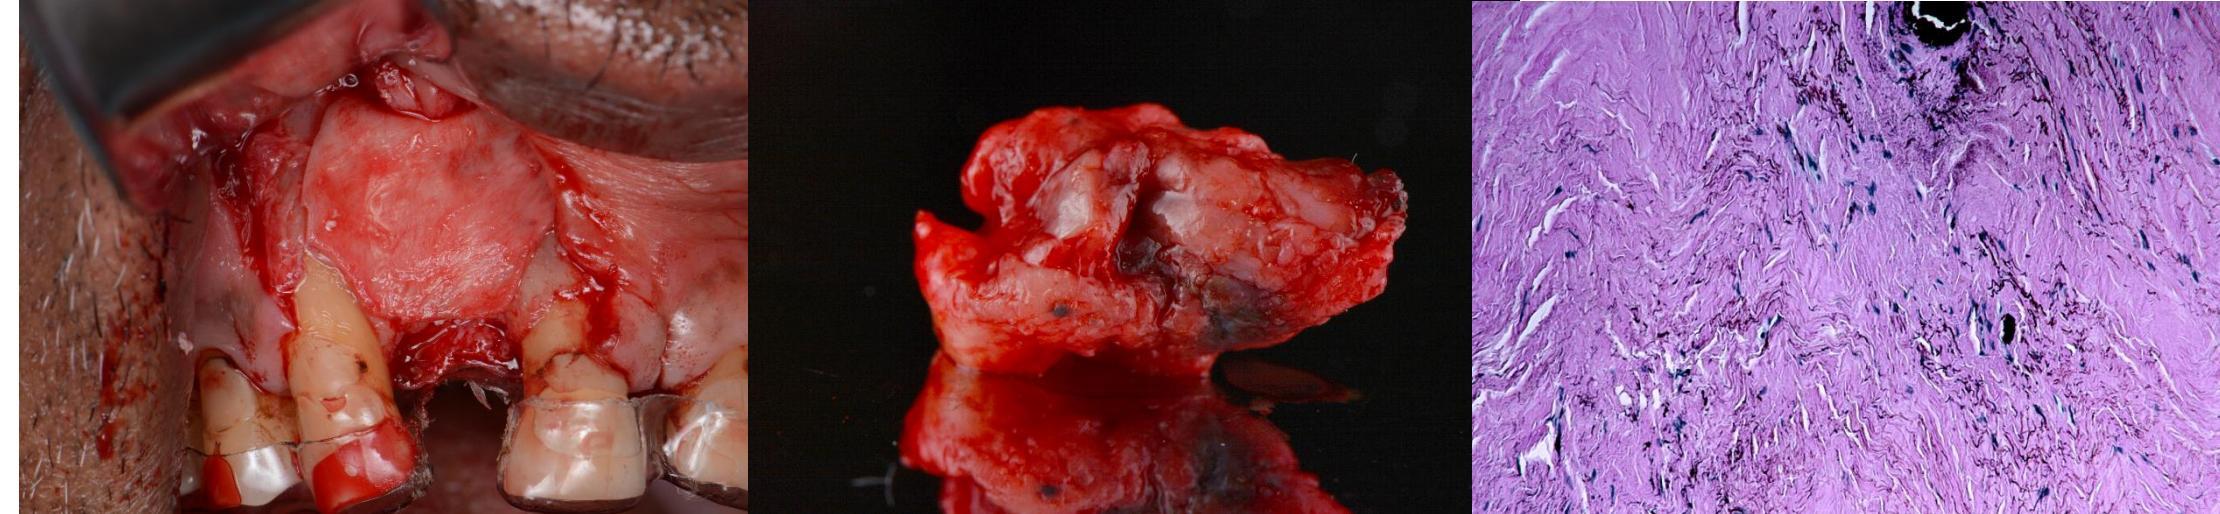
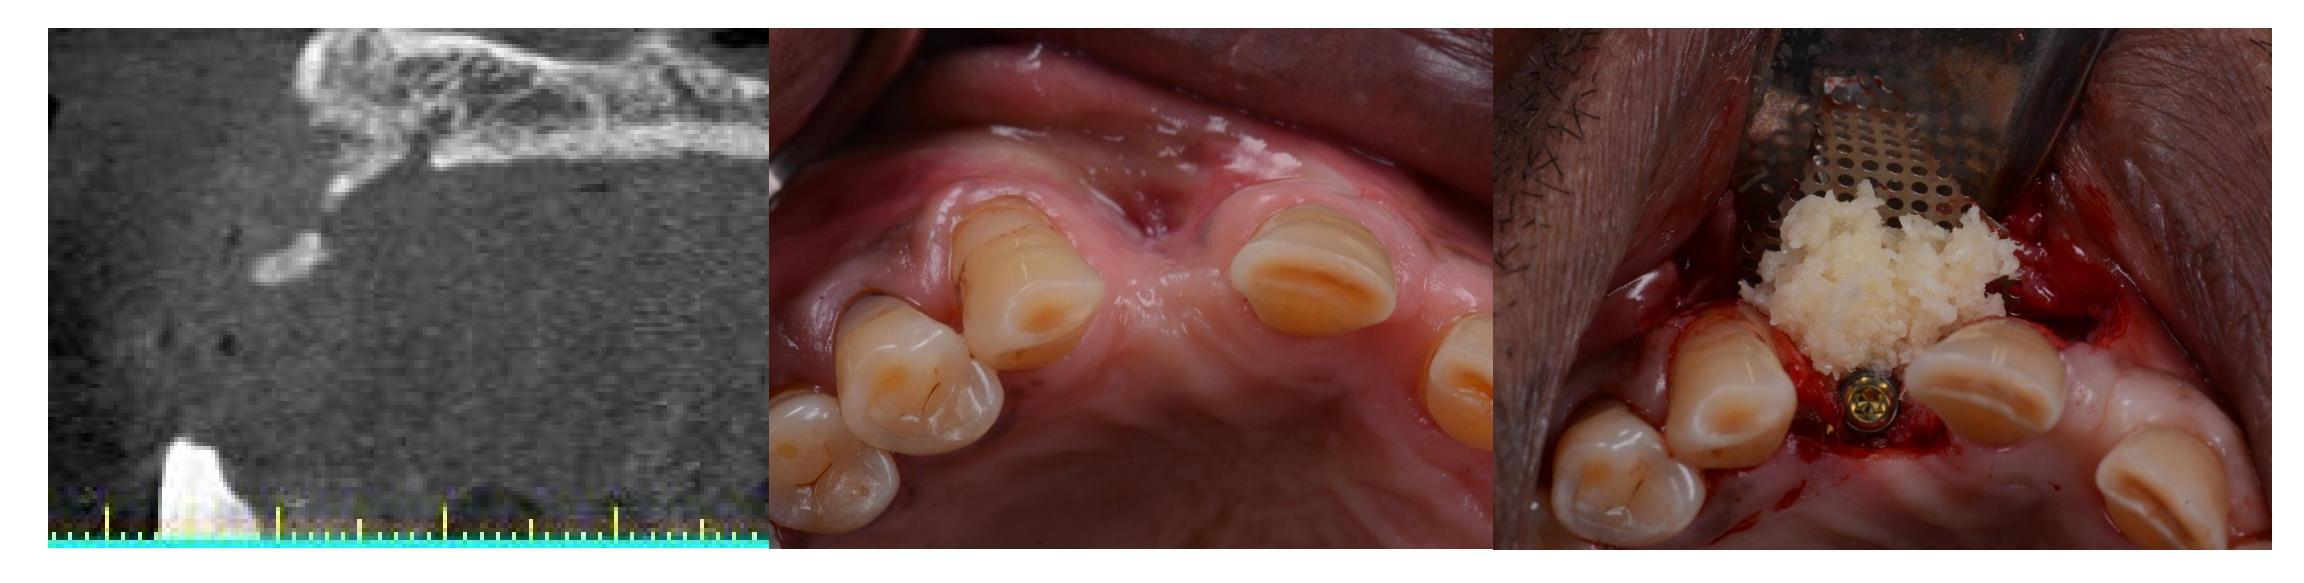
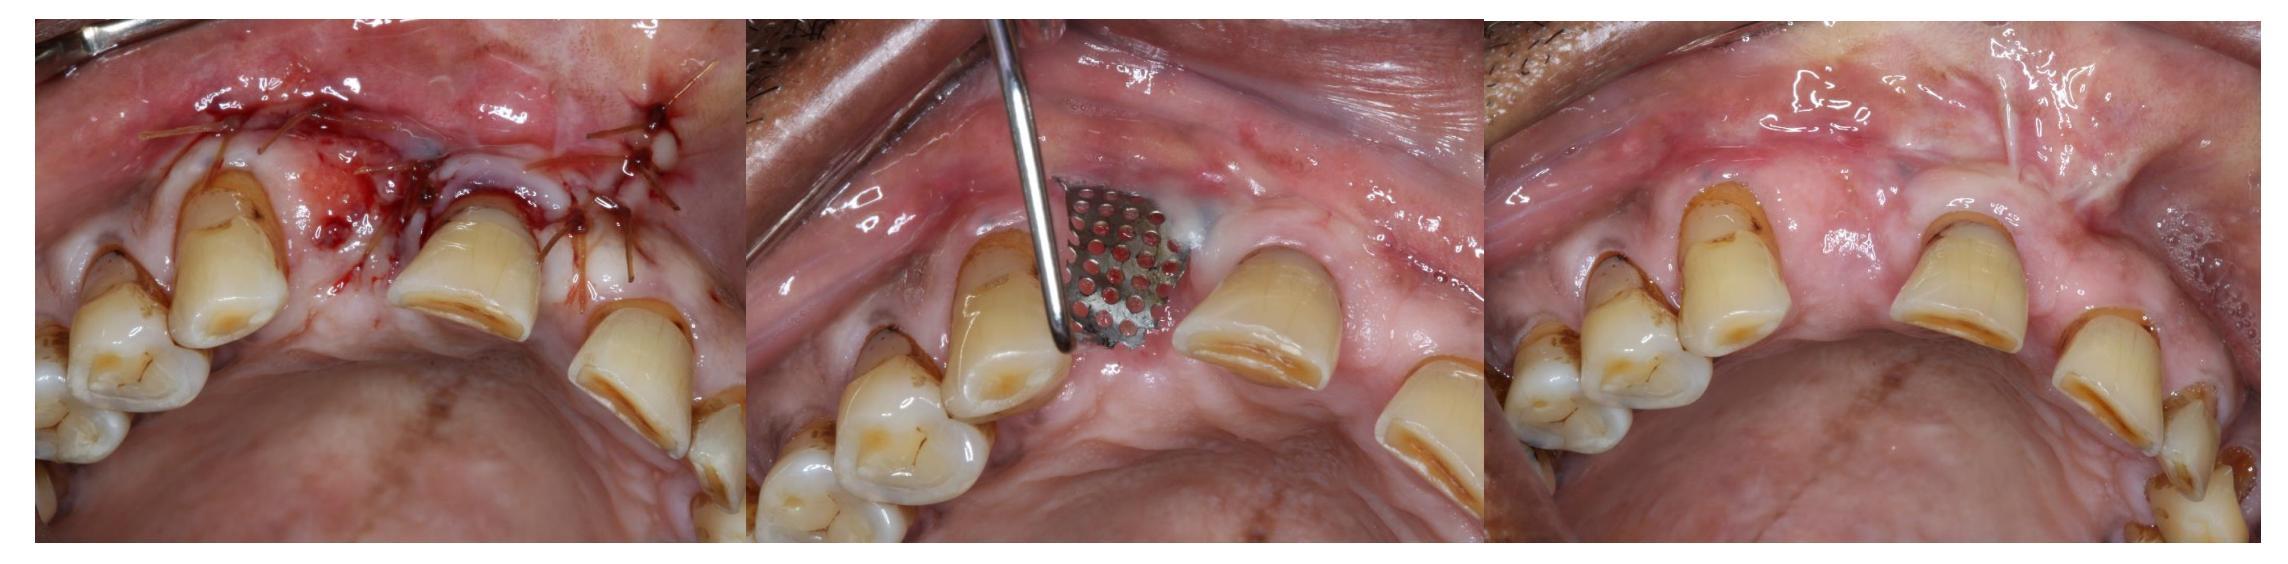
A periapical radiograph showed a well-defined radiolucency in the maxillary right lateral incisor edentulous area. Cone-Beam Computed Tomography (CBCT) revealed large through and through labio-palatal bony defect. An excisional biopsy was planned to establish a definitive diagnosis and management of the lesion before any further surgical or restorative treatment planning of the site.

Enucleation of the lesion and bone debridement were performed. The through and through defect was assessed for complete lesion excision before it was filled with xenograft bone particles (Geistlich Bio-Oss Large Particle & Geistlich Bio-Oss Small Particle & Zimmer Puross Cancellous Particulate Allograft) and packed between the two fitted resorbable membranes (Zimmer Pericardium Copioss) which were contoured and placed labially and palatally. The excised specimen was sent for histopathological diagnosis. A postoperative periapical radiographic was taken to confirm the existence of the bone graft in the bony defect.

At one-week follow up, a labial V-shaped tissue dehiscence in surgical site was observed with partial loss of the labial membrane and the bone graft. The palatal membrane, however, was still intact. The dehiscence was observed and irrigated weekly for seven weeks until the epithelial closure was achieved. A postoperative periapical radiographic was taken which showed the radiolucent area where the cyst was removed in the maxillary right lateral incisor edentulous area.

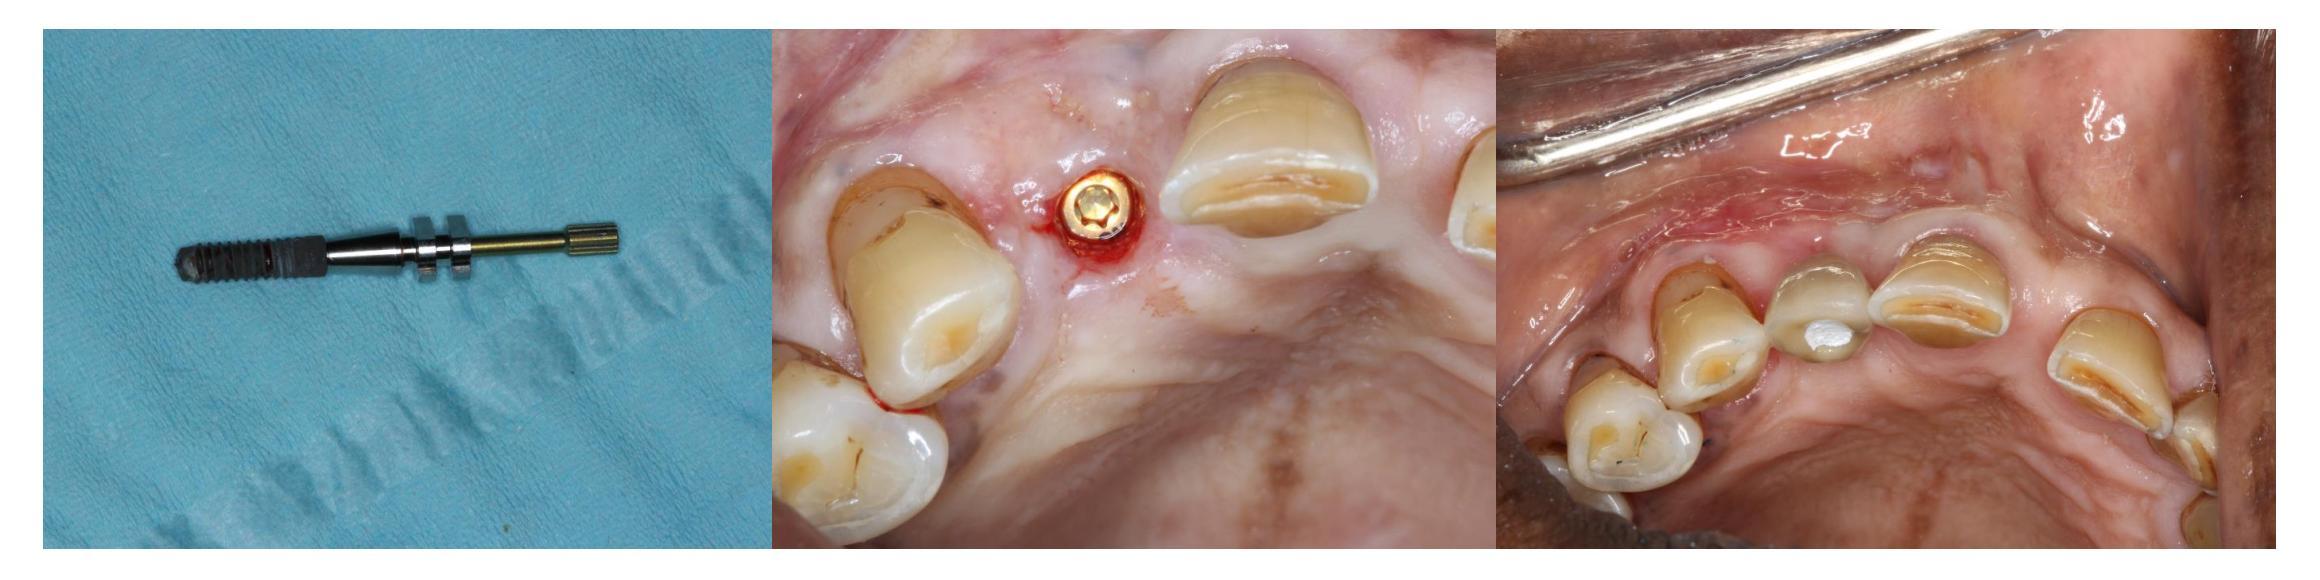
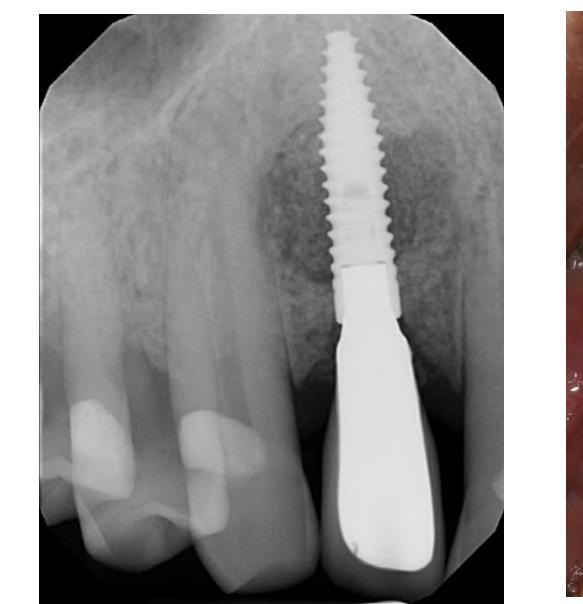
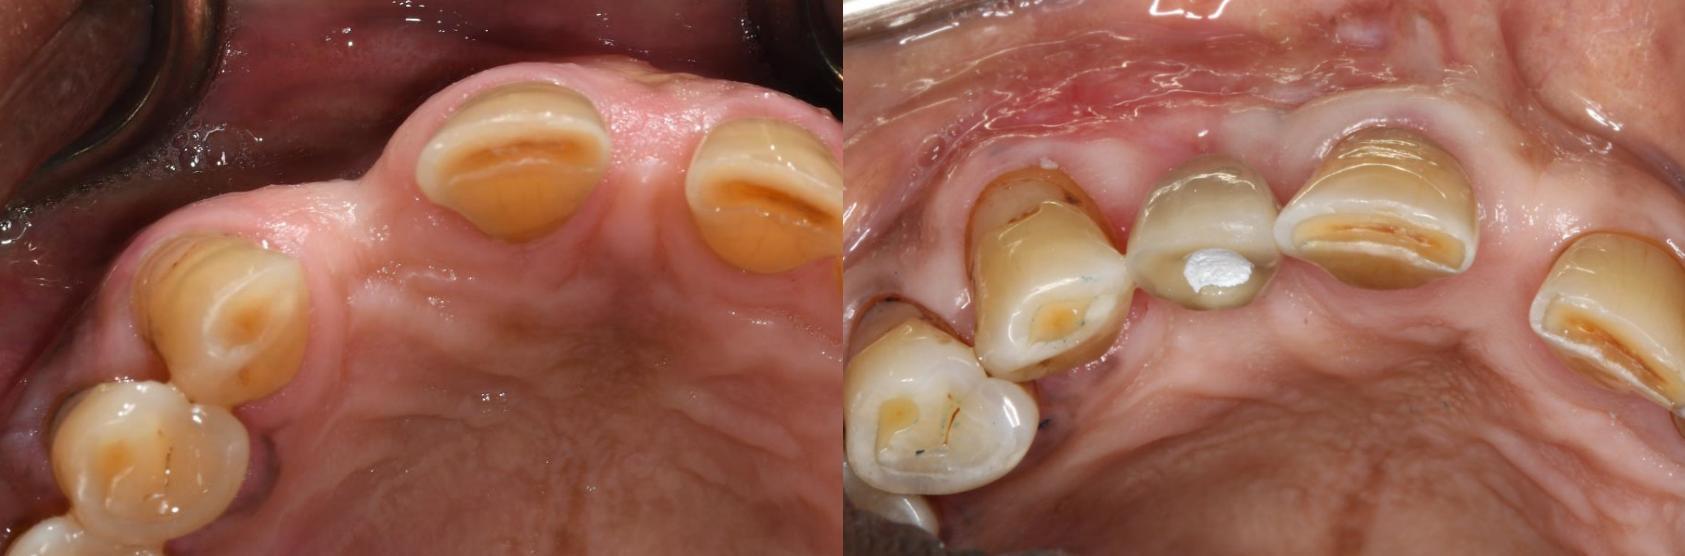
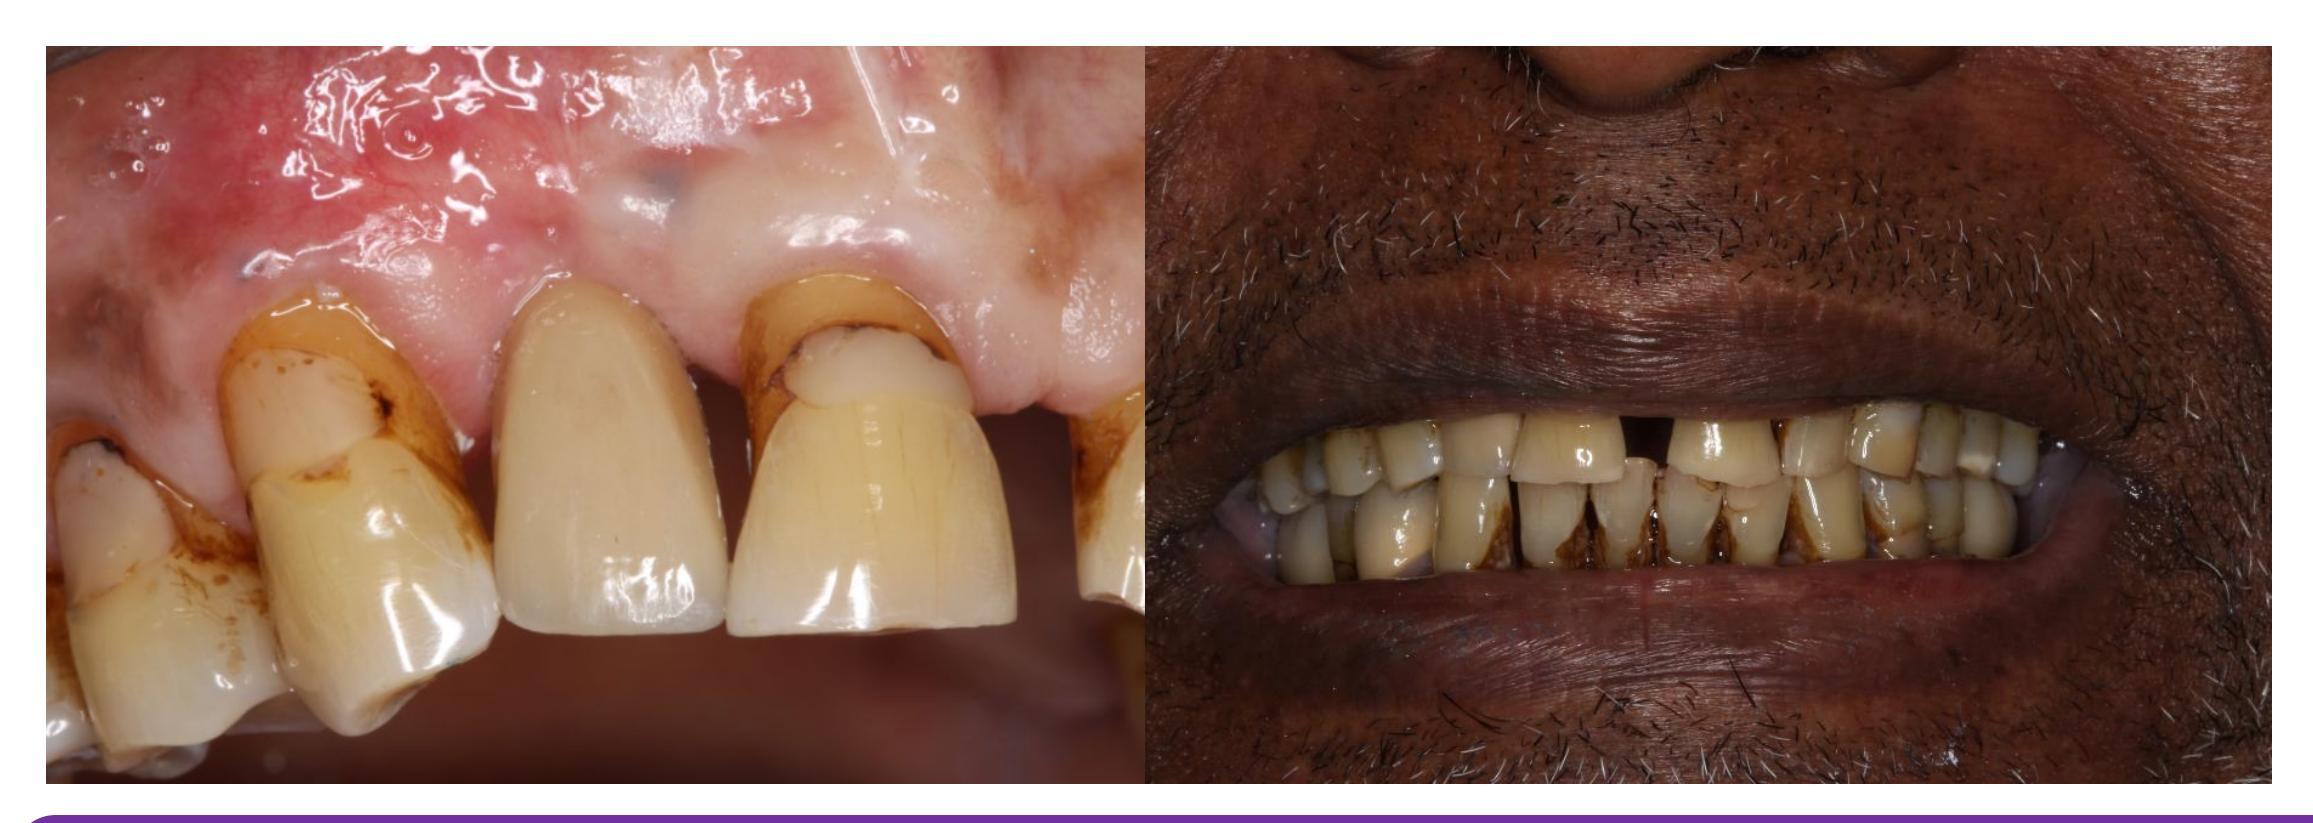
Following soft tissue healing, a second CBCT was performed to evaluate bone healing and to plan for implant placement. The CBCT showed a smaller bony defect with woven bone surrounding the remaining bone graft particles in the palatal area. Guided bone regeneration and implant placement was planned.

The flap was made and reflected and an implant (Straumann 3.3x12 Narrow Crossfit Connection BL SLActive Roxolid, Switzerland) was placed and covered with titanium mesh and bone graft particles (Zimmer Puros Large Particle Cancellous & Zimmer Puros Small Particle cortical). A titanium mesh was secured apically by mini screws while the coronal part was secured by intramucosal resorbable sutures (chromic gut 4/0 suture, Ethicon, Johnson and Johnson Family, New Jersey, USA). A postoperative periapical radiographic was taken to confirm the implant placement and the existence of packed bone graft in the bony defect.

One week later, the titanium mesh was exposed. It was monitored and irrigated with 0.9% normal saline solution weekly until the epithelial closure was achieved. A seven weeks timeframe allowed for the soft tissue to grow under the mesh before the mesh and screws were subsequently removed. At the nine week follow up visit, second stage surgery was performed.

During final impression, the fixture was found to be mobile and removed along with the impression coping and a one-stage flapless implant placement was performed (Straumann 3.3x14 BLT Narrow Crossfit Connection BL SLActive Roxolid, Switzerland). Twelve weeks of healing was allowed before obtaining the final impression. Loading with final restoration was done at fifteen weeks post-op. A Periapical radiograph was taken to confirm restoration seating at loading.

The patient presented one-year post-loading for follow up visit. A follow up CBCT scan was done. Both the clinical evaluation and the CBCT scan showed stable marginal bone levels with no signs (or symptoms) of implant, restoration, or soft tissue complications. There was no recurrence of any pathology. The visual analog score (VAS) scale was used to evaluate patient satisfaction, where zero is equivalent to poor outcomes and 10 corresponding excellent outcomes. Patient gave a VAS score of 9 of 10 for his satisfaction with the treatment outcomes.
